Evaluation of ALON for Cannon Window Application

by Richard A. Beyer and Henry Kerwien

ARL-TR-2358

October 2000

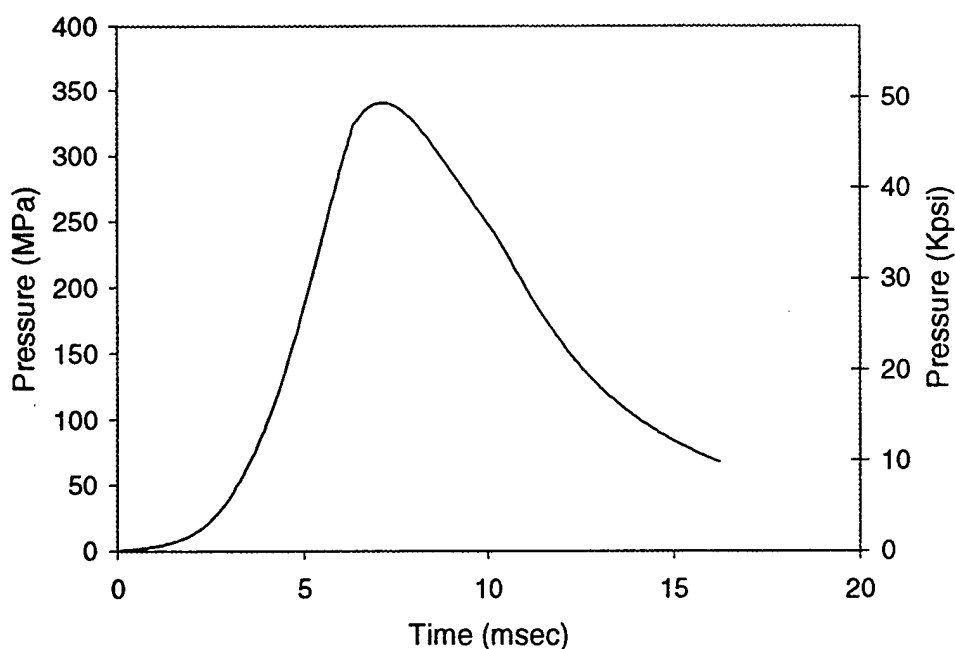
Figure 1. Simulation of Pressure-Time Behavior in a 155-mm Cannon.

During the interior ballistic cycle of a modern 155-mm cannon, propellant is burned at flame temperatures near 2300 °C and pressures of 350 MPa (50 Kpsi) or more. The pressure and highly turbulent combustion environment result in thin boundary layers and highly effective heat transfer to the breech wall. The pressure in a cannon is a well-characterized parameter through both measurement and highly sophisticated computer simulation. The pressure-time profile near the breech from a simulation of a generic 155-mm cannon is shown in Figure 1.

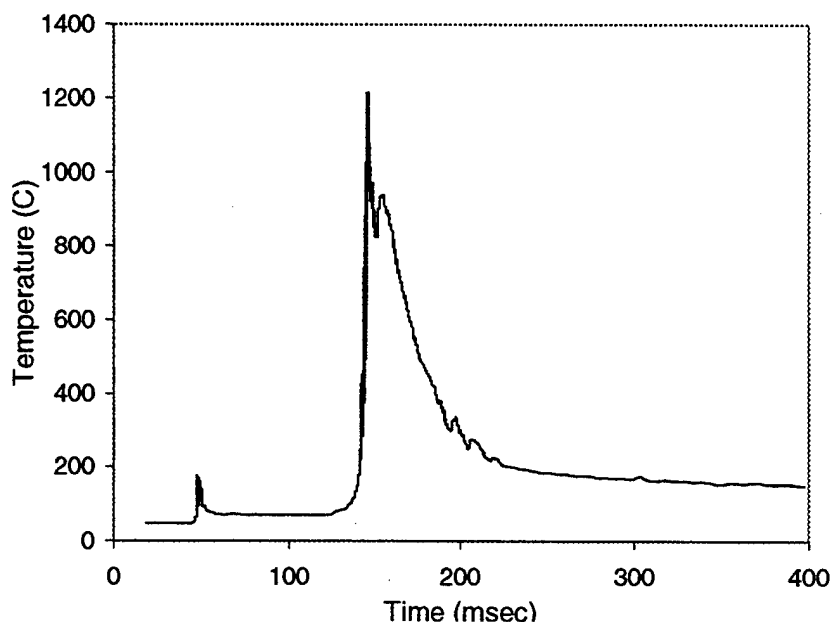
Figure 2. Temperature Measurement on Breech Face During Firing [3].

Bundy [3] made one series of measurements of the temperature history on the breech wall. Although this study was subject to the many problems that can affect instrumentation in this harsh environment, a limited number of temperature-time records were recorded that better define the window environment. One of these is shown as Figure 2. Note that the time scale of the temperature pulse is much longer than that of pressure. Probably, residual heat from the adjacent cannon wall, as well as hot gases in the breech, slow the cooling rate of the temperature probe. However, there is no claim that this profile exactly mimics the window surface environment during a cannon firing. Bundy's report suggests that the peak temperature may be significantly higher than measured.

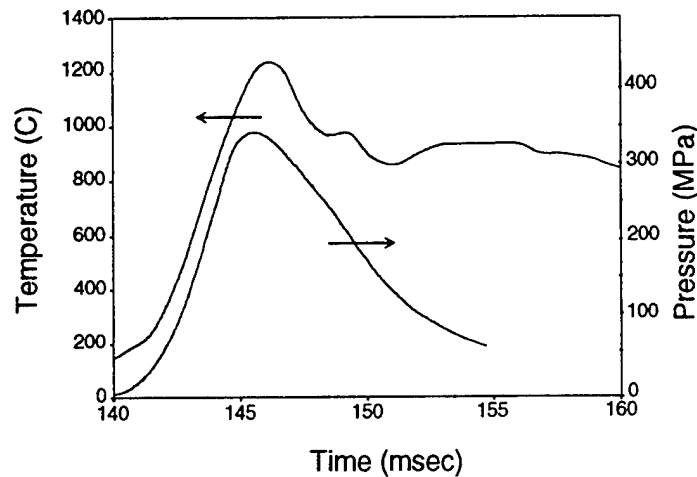
Figure 3. Pressure and Temperature Measurement on Common Time Scale.

In order to compare the pressure and temperature profiles on a similar time scale, data from these two figures are shown in Figure 3 with a time shift to place the nearly coincident rises. As can be seen in the figure, the pressure event and the initial portion of the temperature record are similar in duration.

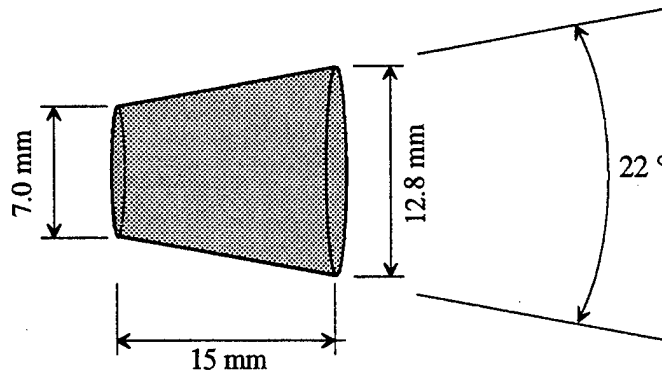
Figure 4. Configuration of Windows and Approximate Dimensions.

The ALON samples used in these experiments were provided by Raytheon Electronic Systems, Lexington, MA. Three windows were fabricated by Kigre, Inc., Hilton Head, SC, into the conical design that has been used successfully with single crystal sapphire. The basic shape is shown in Figure 4. These windows are usually fabricated with all sides fully polished. In order to minimize cost, these ALON windows were polished on the optical surfaces only; the sides were ground. This general configuration is not unlike those found in earlier high-pressure window designs, such as those of Stromberg and Schock [4].

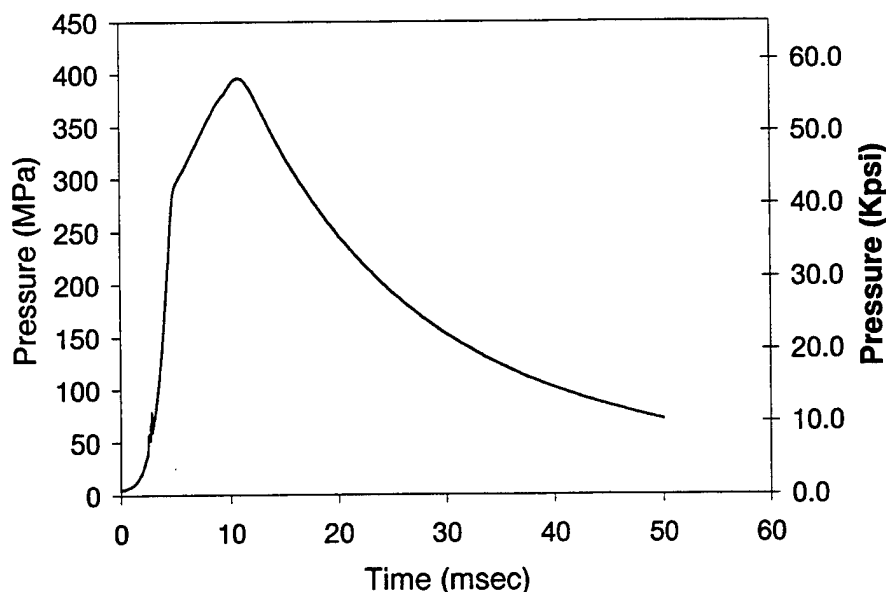
Figure 5. Pressure Record From Test No. 6 of ALON-M.

The peak pressures recorded for these two windows are shown in Table 1. Tests were terminated on ALON-M after the sixth test when the subsurface damage was noted. Because this damage was internal and it was surface damage that was most closely monitored, it may have begun to fail at a lower pressure. The target pressure for test no. 6 of window ALON-E was between 55 and 60 Kpsi.

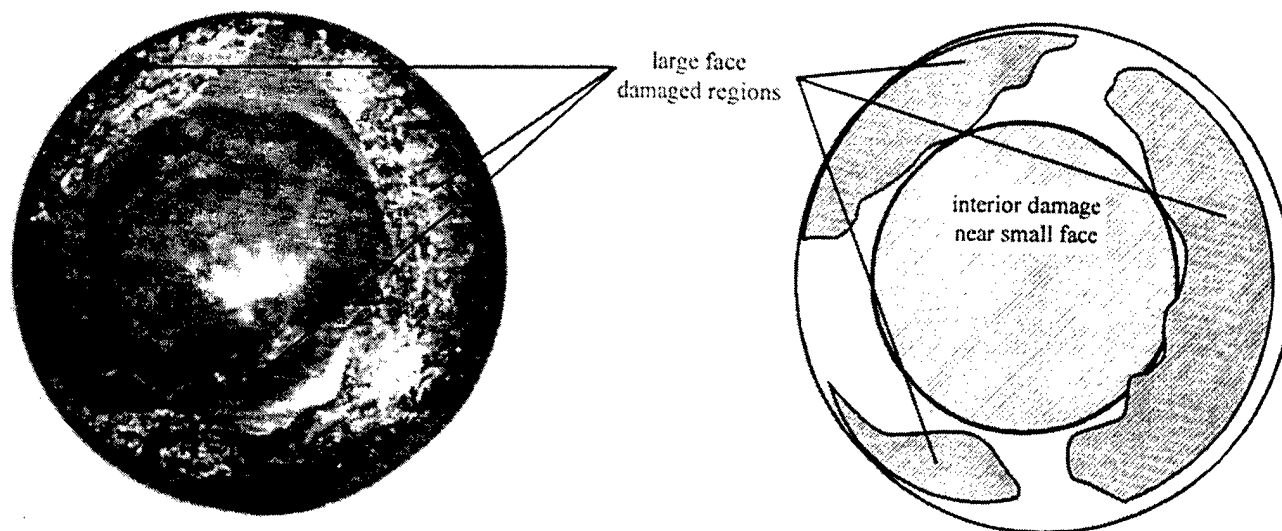
Figure 6. Photograph (Left) and Diagram (Right) Showing Damage to High-Pressure Face of ALON-M After Tests.

Window ALON-M showed damage in two regions. The hot-face damage increased in area by more than a factor of two. As shown in Figure 6, a sufficient center aperture remains clear; this window would still be usable if this were the only damage. However, since this damage is from a limited number of cycles, it is not likely that this method of seating is appropriate for ALON. Thus, this damage alone would probably be sufficient to rule out ALON seated in metal as a useful configuration for our purposes.

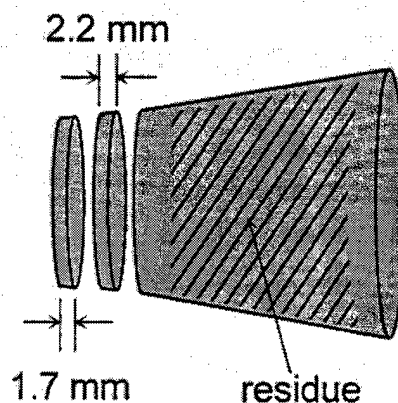
Figure 8. ALON-M After Removal From Case.

The window was pushed out of the case so that the window, case, and metal interface could be examined in detail. It fractured cleanly into three parts, as shown schematically in Figure 8. Two small slices were broken from the smaller end. Both breaks were nearly normal to the window's axis of symmetry. The lower break was quite flat. The other was curved slightly toward the large face. The thickness of these pieces was measured at approximately 1.7 and 2.2 mm, respectively.
